Manhole Inspection Summary

Manhole # S07KK1021MH

Insp Date: **6/6/07 1:09 PM**

Location Address: **4923 REISTERSTOWN RD**

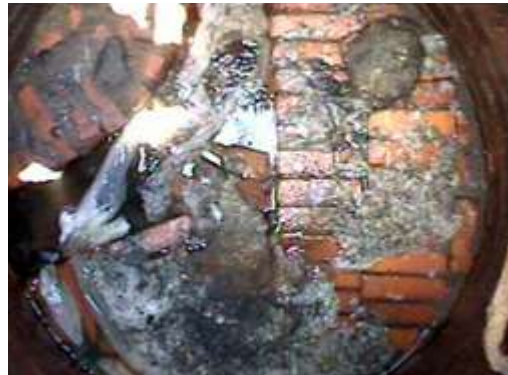
Top View

BENCH AND CHANNEL DEBRIS

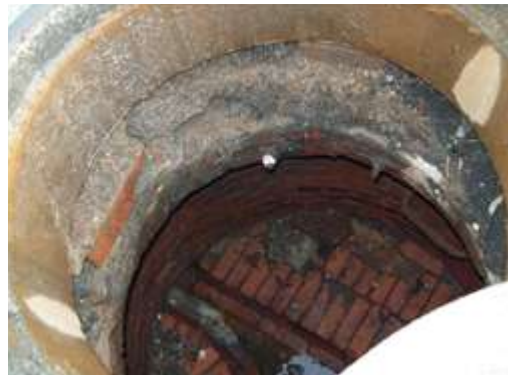
Defect 2

Condition: ☐ Sound ☐ Cracked ☐ Root Intrusion ☒ **Loose Brick** ☒ **Deteriorated**

CHIMNEY LOOSE BRICKS AND
DETERIORATION

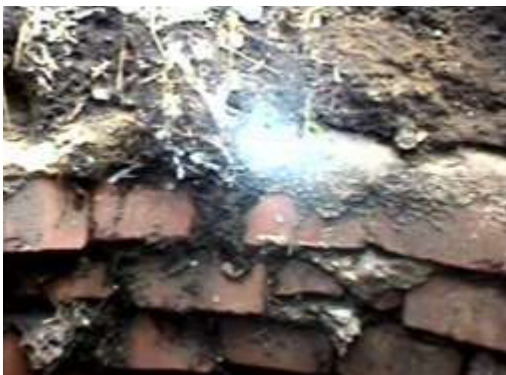
Defect 1

Count: **2** Missing: **1** ☒ **Corroded**

CORRODED/MISSING RUNG

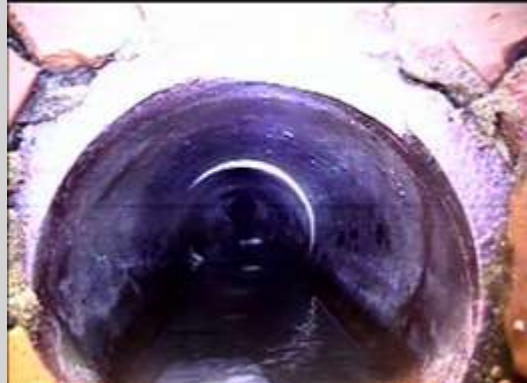
12 O'Clock Outflow

BENCH AND CHANNEL DEBRIS

Pipe Height: (in.) Direct
Pipe Material: **Clay** ☐ Pipe Lined
Invert Depth: **5.64** (ft.) Flow Characteristics: **Slow**
Deposits: ☒ None ☐ Mud ☐ Sludge ☐ Debris ☐ Grease
Silt Depth: (in.) Deposits Extent:
Infiltration: **None** Pipe Seal Cond: **Cracked**

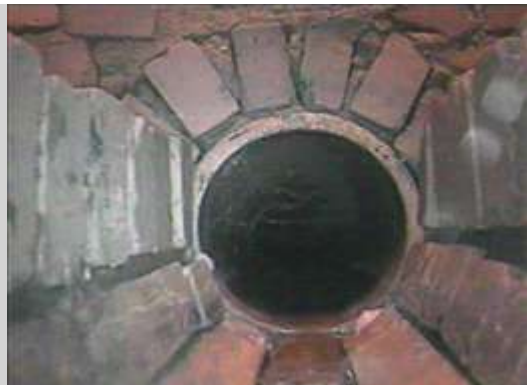
6 O'Clock Inflow

BENCH AND CHANNEL DEBRIS

Pipe Height: (in.) Direct
Pipe Material: **Clay** ☐ Pipe Lined
Invert Depth: **5.62** (ft.) Flow Characteristics: **None**
Deposits: ☐ None ☐ Mud ☒ Sludge ☒ Debris ☒ Grease
Silt Depth: **8** (in.) Deposits Extent: **Heavy**
Infiltration: **None** Pipe Seal Cond: **Unknown**

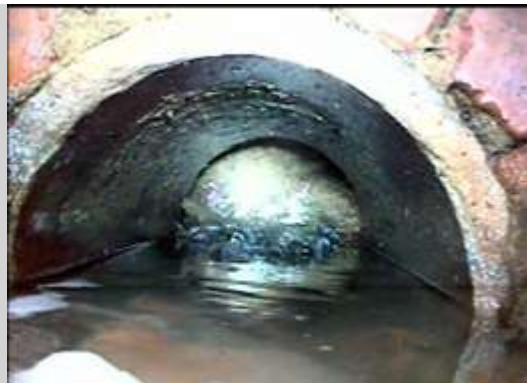
9 O'Clock Inflow

BENCH AND CHANNEL DEBRIS

Pipe Seal Cond: **Cracked**
